TORQUETUBE

**Magazine of the Riley Motor Club, Qld, Australia Inc.
August 2018**

Horn push rebuild

Fuel tank repair

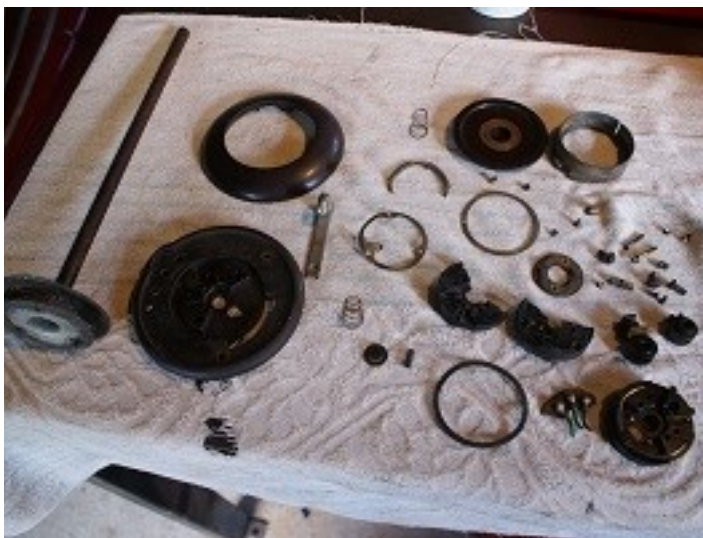
Above: The bits

The three screws holding the Bakelite horn push to the inner steel column were undone and the horn push withdrawn a little way from the inner column and the wires were cut again. The inner column in its two pieces were then set aside and the horn push was placed on the operating table that had previously been covered with a thick clean white cloth. The first thing done was to remove the three horn push retaining bolts so that the horn push cover, the

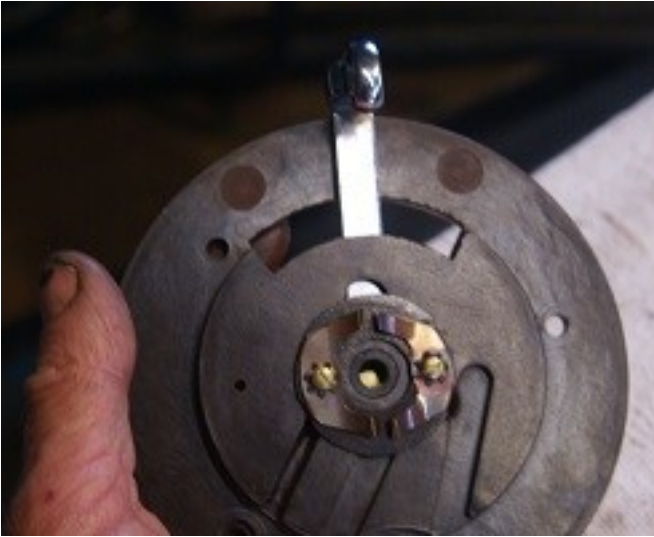
Above: The horn contacts with their bolts at 3 and 6 O'clock and below when the horn contact is removed the trafficator arm retaining bolt is revealed.

When the horn push is situated so that the trafficator lever is at twelve o'clock, the nut at six o'clock simply holds the triangular trafficator pivot point in its place and it holds the two main parts of the horn push together. It was the last nut to be undone. The contact point nuts were all unsoldered and the two nuts and bolts at 3 and 9 o'clock that hold the brass horn contact in place were removed allowing the horn push contact on the other side of the horn push to be removed. Then, the nut holding the brass ring was removed. The horn push was again turned over and with the horn push contact removed, the nut that holds the trafficator lever in place on the other side of the horn push was revealed. This was unscrewed, and the chromed lever was withdrawn from the trafficator mechanism. Then the nut situated at six o'clock was removed and the two parts of the horn push came apart.

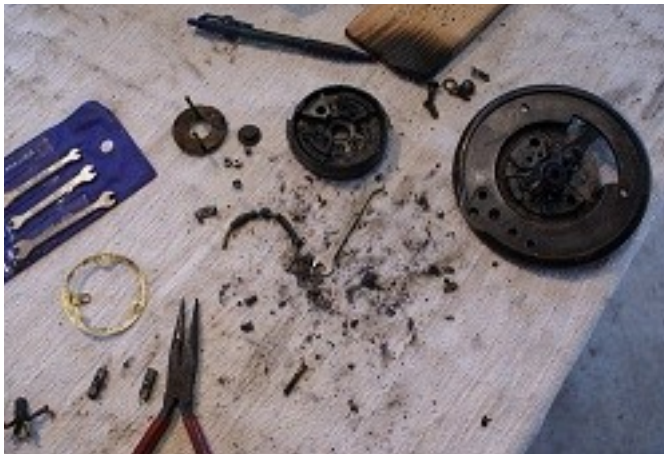
The inside of the horn push was revealing. It was full of graphite grease, a good conductor of electricity. It was all of this grease that had tiny particles of conductive metal in it that was the smoke culprit. The white tablecloth was now taking on the colour of graphite grease.

The horn push was all washed out and the component parts of the horn push and trafficator mechanism were washed and cleaned ready for reassembly. Another interesting feature of this horn push was that the left-hand return spring for the trafficator was broken preventing cancellation of the trafficator when turning right.

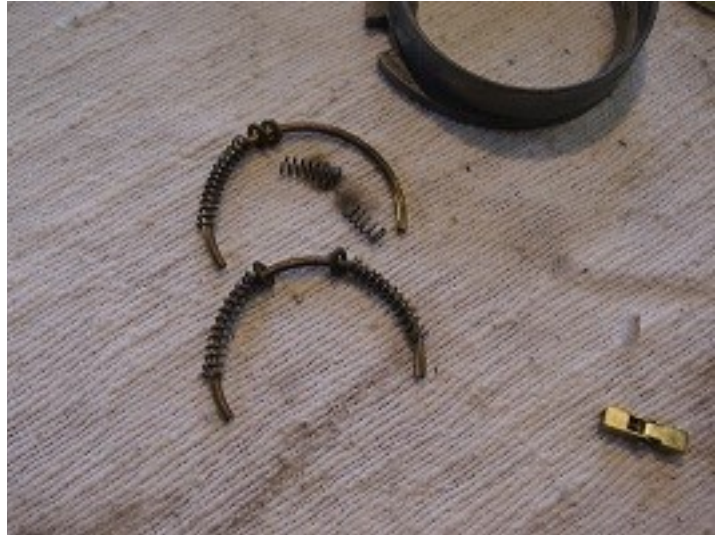
Above: The broken return spring

There was also something very important that I forgot to mention at the beginning of this little article; the component parts are very small, and it is easy to lose one or two of them making the trafficator assembly unusable so lots of care needs to be taken to retain the parts. This is particularly the case with the tiny wheel in the trafficator mechanism. It is fitted into a square carrier and this is tensioned in place against the pivot point with a spring.

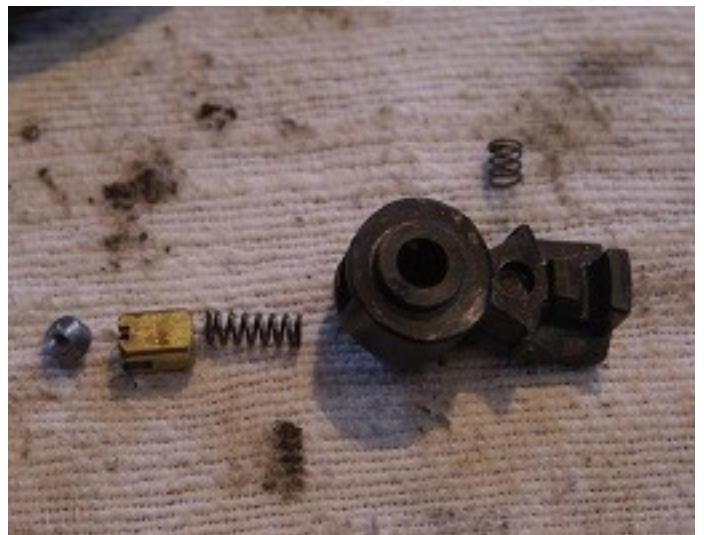
Below: Trafficator Bakelite centre with spring, carrier, and wheel

Assembly happened in this order: The spring, steel carrier and tiny steel wheel were put back into the centre piece of the bakerite trafficator assembly. The steel wheel only fits into the carrier one way and the wheel needs to fit into a horizontal position. It is on the opposite side to the chrome trafficator arm. There is another small spring that was placed into an indent on the top side of the trafficator selector.

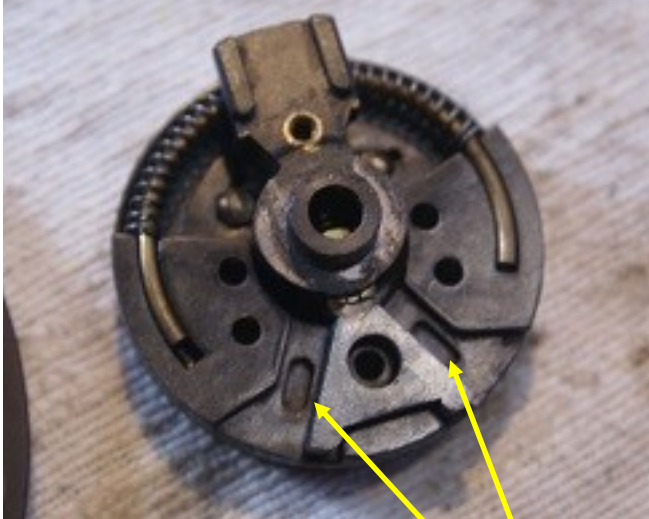
Above: The centre piece with trafficator selector, the springs and the triangular pivot

Location of the self cancelling lugs

This was then fitted into the centre of the horn push body and the triangular pivot point was pressed into its position against the tiny steel wheel. The two self-cancelling lugs were then fitted into place so that the angled sides were facing outwards.

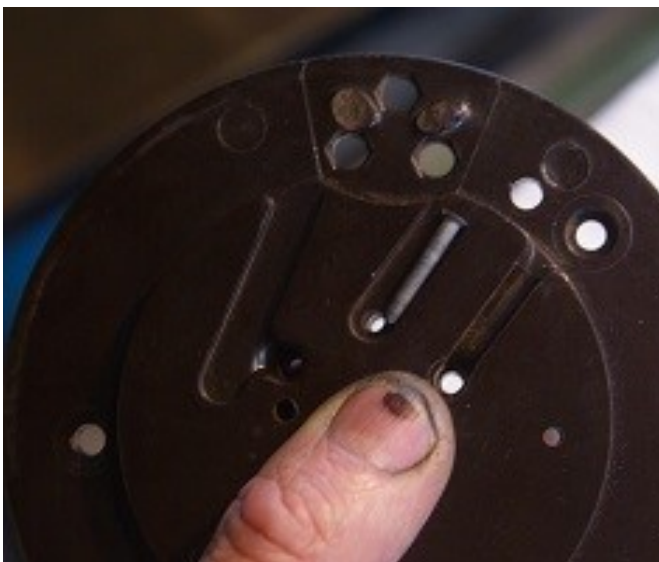
Above: The location for the bolt that holds the triangular pivot in place

the bolt holding the triangular pivot point in place was fitted and the nut done up.

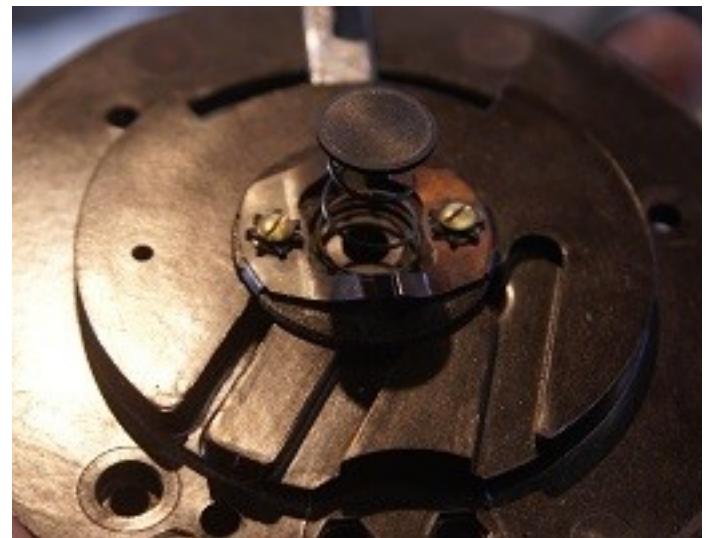
Above: The horn push contact with its spring and button. The spring and button the other way up.

The next step was to fit the chrome trafficator lever back into its place and the tiny bolt that fixes it into its position done up. The horn push contact was then fitted into place with its two bolts passing through the body of the trafficator. The nuts were then re-fitted and done up on the other side of the horn push. After that the last bolt was passed through the horn push body, the brass ring fitted, and the nut was done up. And finally, the horn push spring, button horn push centre and outer body was fitted, and the three retaining bolts done up.

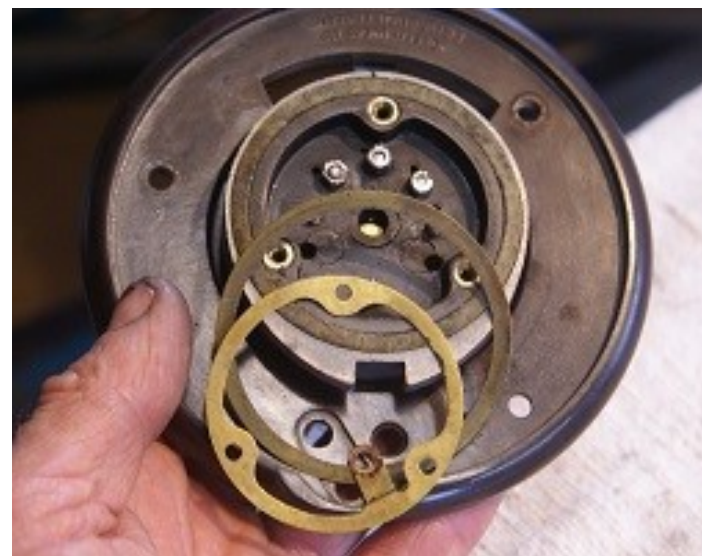
Below: Trafficator centre piece assembled and trafficator assembly brass ring being fitted.

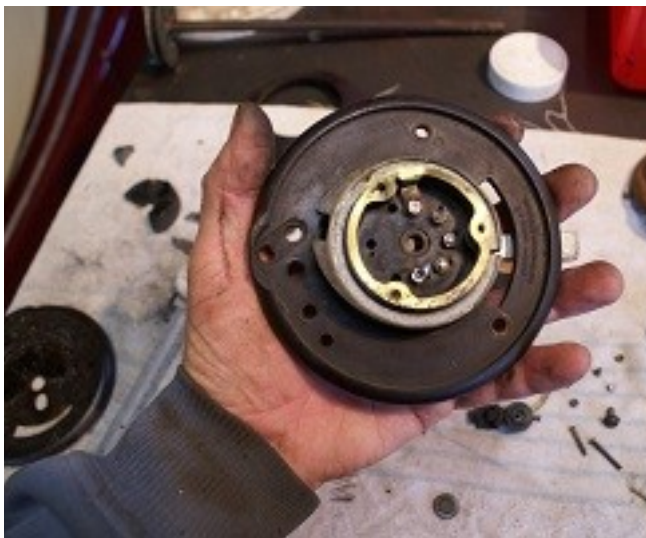
Below: Horn push and outer cover fitted

The metal cancelling ring was then fitted over the Bakelite horn push body. When working on the horn push it will be noticed that this ring is split on the opposite side of the self-cancelling mound on the inside of the ring. It is worth pushing a screw driver into the split and twisting it to ensure that the ring fits loosely over the horn push body, otherwise it may foul on the self-cancelling lugs. In the case of this horn push, a smidgeon of grease was wiped along the inside the cancelling ring to ensure a smooth sliding operation of the self-cancelling mechanism.

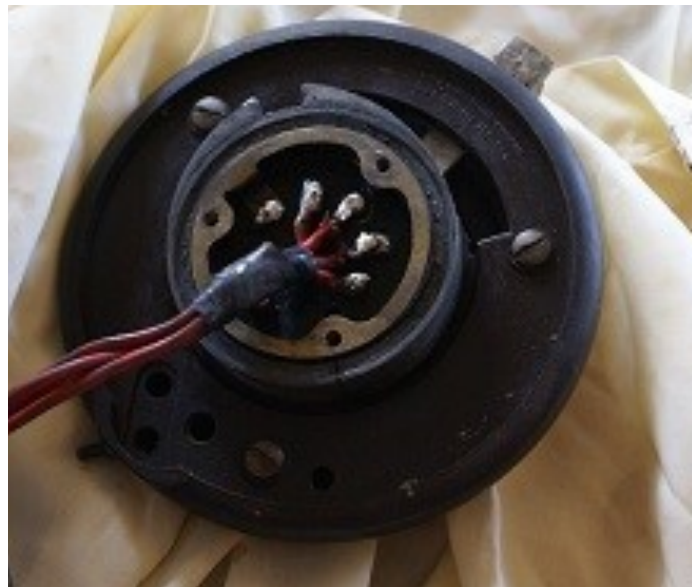
Below: Wires to the horn push (not the one repaired) wires should be from the left; red—trafficator left, green power, yellow trafficator right and purple—horn

It was then decided to change the wires in the inner steering column and so red, green, purple, and yellow wires were wrapped in tesla tape, passed through the two sections of tube, and soldered to the contact points on the horn push and then the three retaining bolts were fitted and tightened to complete the surgical operation. The horn push was then ready to be fitted back into the steering column.

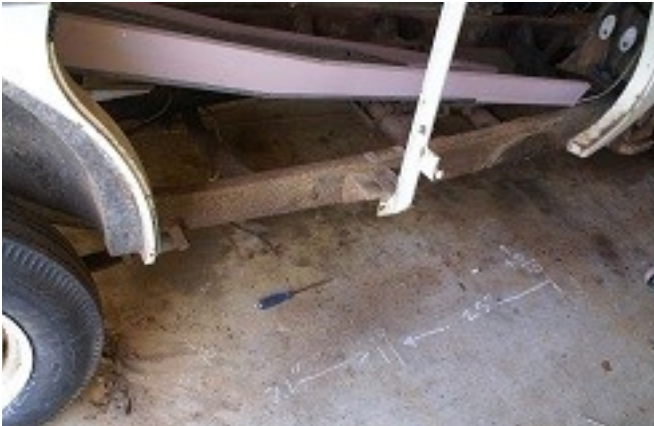
Below: Driver's side of the body lifted, position of sill measured and then removed

In brief, the first step was to replace the sills, replacing one sill at a time in precisely the same position where the originals were located taking care to ensure that the originals had not collapsed or shifted during their years of use. The first thing to do is to measure the distance between the outside edge of the chassis and the outside edge of the sill at the front, middle and back. The distance between the front edge of the tub to the 'B' pillar and from the 'B' pillar to the quarter panel is also noted. The angle and location of the 'B' pillar on the sill also needs to be carefully noted. Of vital importance is that when the sills are replaced that the front fixing bolts pass through the sills at the point of the angle on the side of the sill. If that is not done, later when the car is assembled the hinges will bind when trying to close the front doors

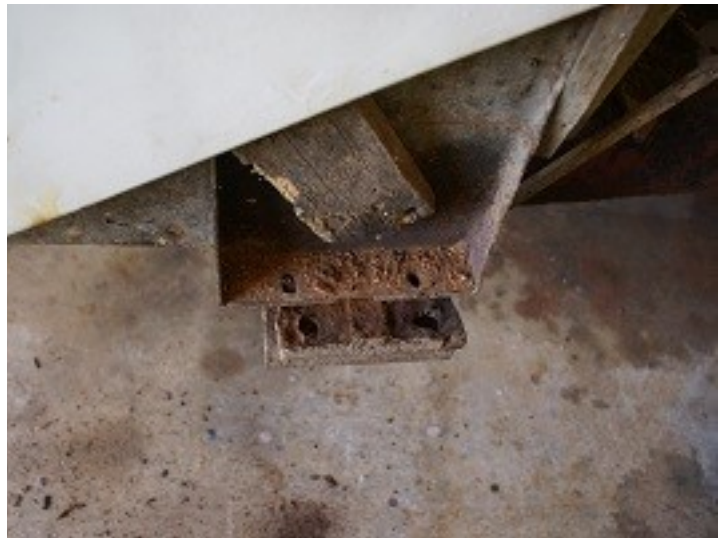
Above: 'K' panel lifted with a jack on the rear wheel. Notice the original packing on the chassis.

On this Riley, because the body was mainly intact, the driver's side of the body was carefully lifted with a scissor jack sitting on the rear wheel. The body is lifted just high enough for the sill to slide past the front edge of the tub section; or raised about 2 inches. The sill was then withdrawn towards the back of the Riley and away.

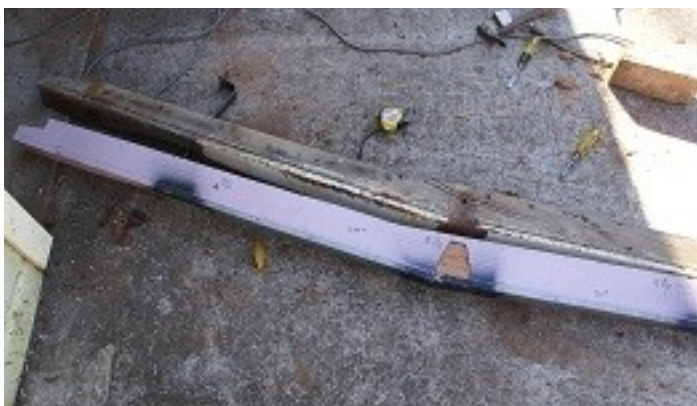
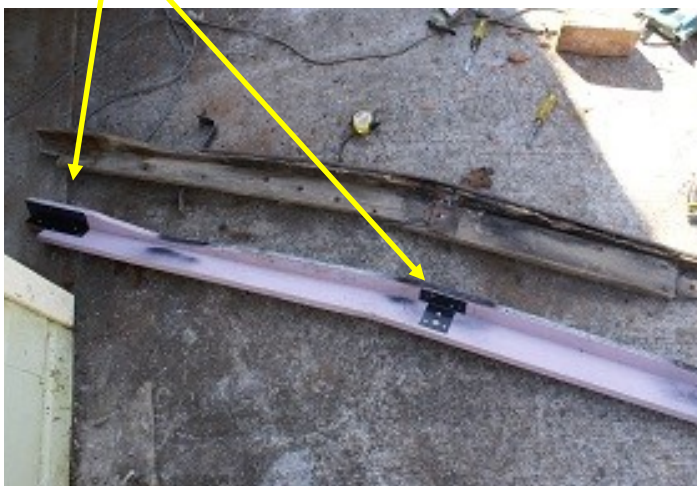
Above: The new sill and the old sill compared and the new sill shaped to the old and below: The bottom side of the sill. Note the steel for fixing the K panel and the 'B' pillar

The new sill was then placed back into the original position of the old sill with the same height of packing. The packing under the 'K' panels, 'B' pillar and the front side of the tub were replaced with pieces of an old plastic kitchen cutting board; a marvel of modern recycling on a vehicle that is already saving the planet 720 Kg of CO2 gas for every thousand dollars spent on restoring a Riley instead of buying a modern car whether recreational or not (1). Counter sunk bolts were then fitted through the base of the 'B' pillar and secured to the sill, the front of the tub was secured to the sill with four screws and four ¼ inch bolts were fitted and secured through the 'K' panel into the sill. The foundation of the driver's side of the Riley was now fixed into its correct position. The same procedure was then performed on the passenger side of the Riley and when both sides were done the sill was temporarily re fastened to the chassis with bolts of the same size as the originals through the tub, 'B' pillar and 'K' panel. This was done to ensure a firm foundation for the timber frame to be built above the sill.

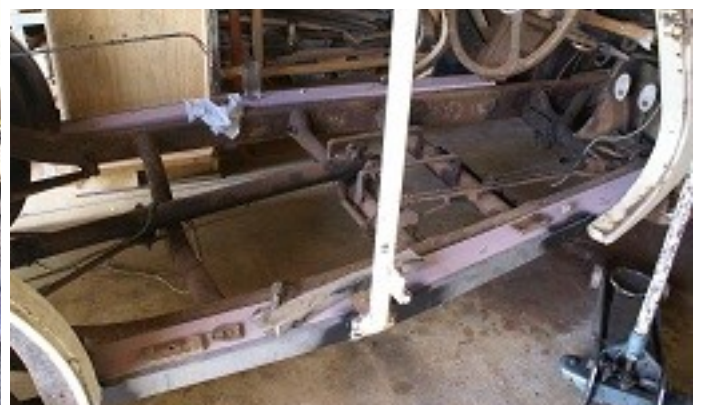
Below: The sills fitted

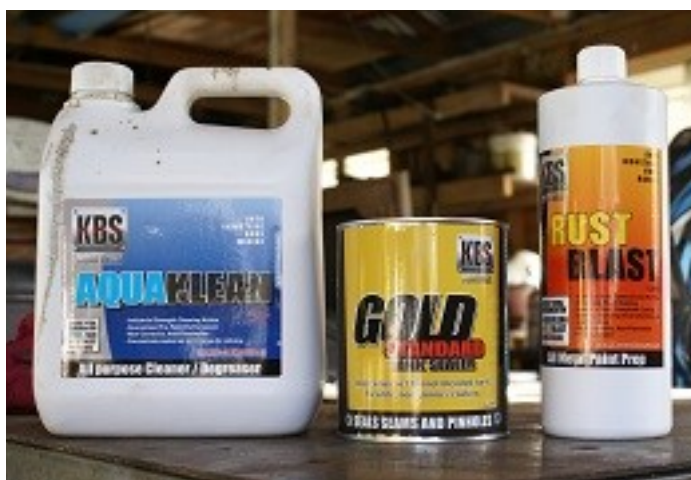
Above: The products used

To make sure of the cleanliness and seal of the tank, the products purchased at the car shop were employed. The first step was to block off all the openings to the tank. A piece of sheet metal was cut and drilled to accept the sender unit retaining bolts and this was utilised to cover the sender unit opening and two 28 mm sockets wrapped in plastic were utilised to block off the filler openings. The instruction sheet said that the 'Aquaklean', product is used first. The instruction sheet said to use the solution one to one with warm water, so the mixture was made up and poured into the tank and my socket bung was put in place and the solution swished about to cover all of the interior surfaces. After sitting the tank right way up, sideways, upside down etc over a period of an hour the drain plug was removed, and a reddish substance ran out of the tank into a bucket that I had positioned next to the tank beforehand.

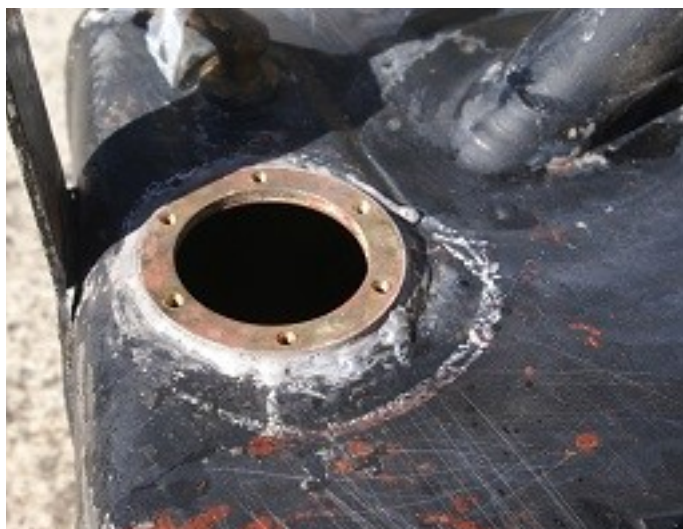
It was not accident damage or rust from long disuse, the soldered top seam on the passenger side had split during 70 years of motoring vibration. The leak had been noticed a few years ago but it was right at the top of the tank, so it was left for a more convenient time for repair. That time had come so a visit to the local car shop was made and a very helpful sales team sold me a product called Autofuel Tank Sealer kit (KBS Coatings). The package contained products called Aquaklean, Rustblast and Rustseal. Brett told me that the product could only be purchased for a 50 or 100 litre tank sizes and since the RM tank held something in between these amounts the 100 litre tank product was purchased. Later, it turned out to be the right choice as it was decided to take out the 12/4 Falcon tank and test and clean it as well.

Above: Apart from the small seam split the sender mount had split as well.

The drain plug was then refitted, and the tank filled with water. Tipping it to its side revealed the location of the split and this was circled with white chalk. The tank was too big a heat absorber for my soldering iron, so I elected to use an LPG torch.

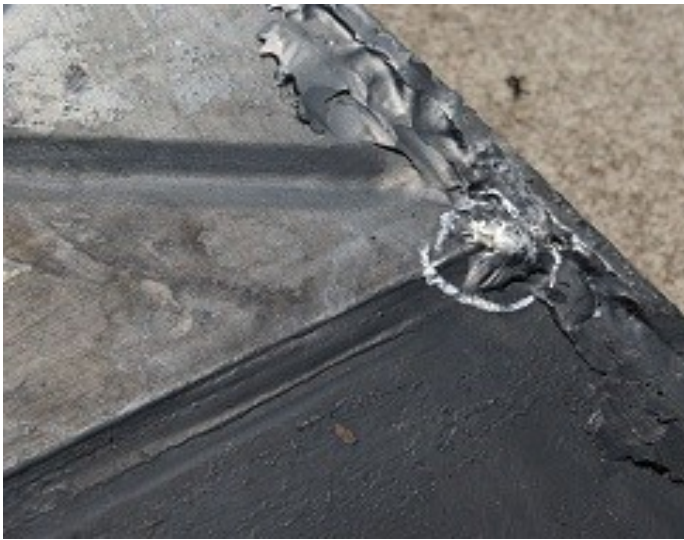
Above: The liquid seems to be a mixture of lead and the colouring agent (red lacquer) used in the previous century

Yes, the fuel was completely drained away and the tank dried before filling it with water, so it didn't blow up and I still have my moustache and eyebrows. With the water drained soldering the join was an easy exercise and with this done the tank was retested with water and this revealed a pin hole in the same area. The procedure was again repeated and after the second soldering exercise there was no leaks on that side of the tank. With the tank filled with water the other side was checked and it was found that the solder around the sender unit had given way as well, so this was cleaned and soldered until no further leaks were detected.

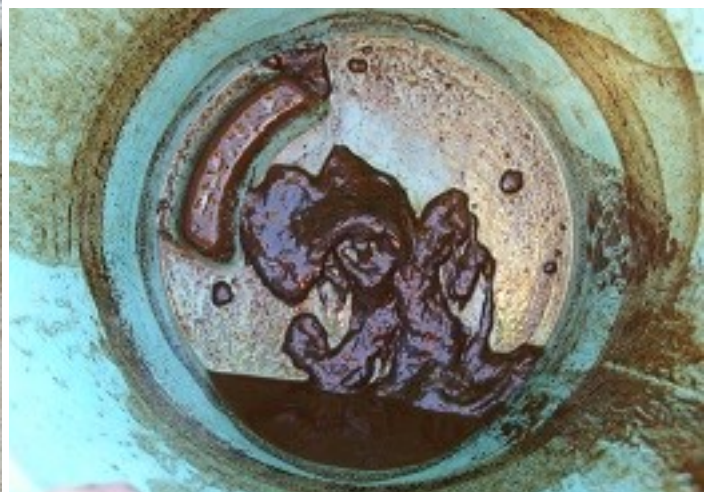
Below: 12/4 fuel tank gunk

The second wash out was less solid. But after three washes there was still a thick mass of gunk at the bottom of the tank and no product left to do another wash. At that point it was decided to purchase some paint stripper to see what effect it might have on the 90-year-old gunk. The paint stripper was poured into the tank, swished about and left in the upright position for 3 hours, then each side for about the same amount of time and left for 24 hours. After that time the now red remains of the paint stripper was poured out and the tank cleaned out with water. Happily the tank came up sparkling clean.

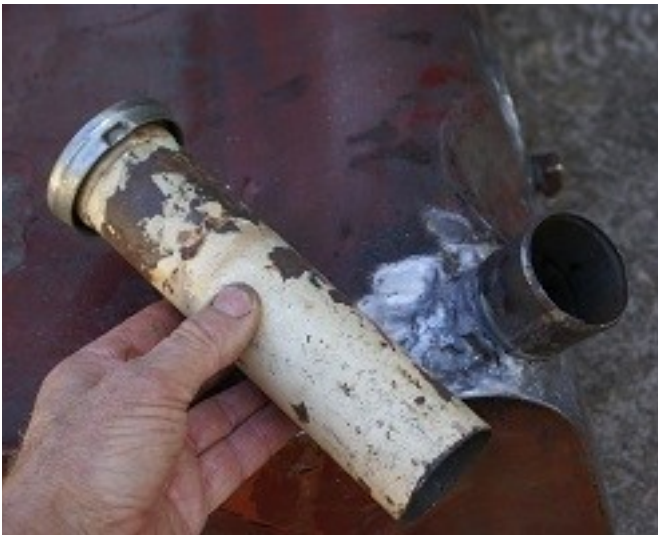
One of things discovered with this fuel tank was that the filler tube was missing. There was also a split in the tank adjacent to the filler opening.

To solve this little dilemma, it was decided to cut the bottom end off the top filler pipe, cut it to make tabs to solder onto the tank and solder it onto the tank at the same time as soldering the split. A complicating issue was that the filler point was on the top rounded edge of the tank and the filler tube was raked at an angle. A quick trip to my local car shop produced some fuel resistant rubber hose so this was fitted to the top filler pipe and pushed over the piece that was cut from it. In this way the angles could be measured, and cuts were made into the pipe to form the tabs. A few of the tabs were drilled to accept small metal screws to hold the filler pipe in place on the tank. This

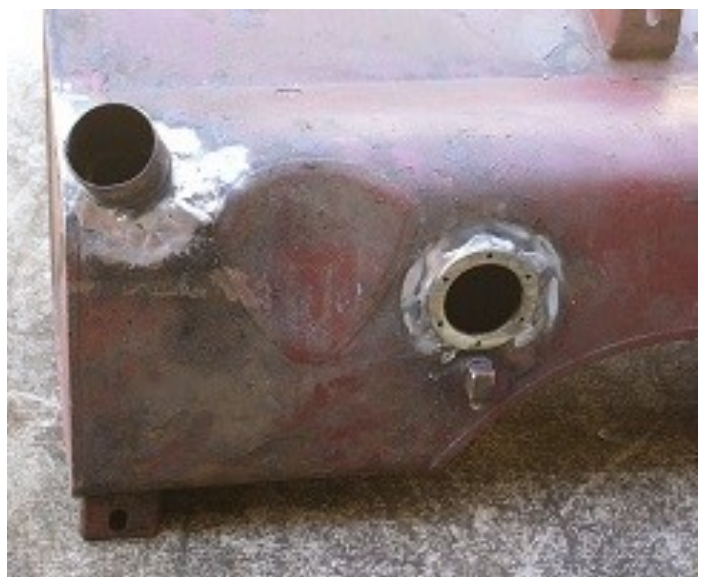
Below: The fuel tank soldered

The filler opening was then attached to the tank using the small screws and a magic product was taken out of the lead wiping cupboard. It is a soldering paste that was purchased from Blackwood's. It has lead filings as well as a flux paste mixed together. This was applied, and a 50/50 soldering stick was used to cover the joins right around the opening.

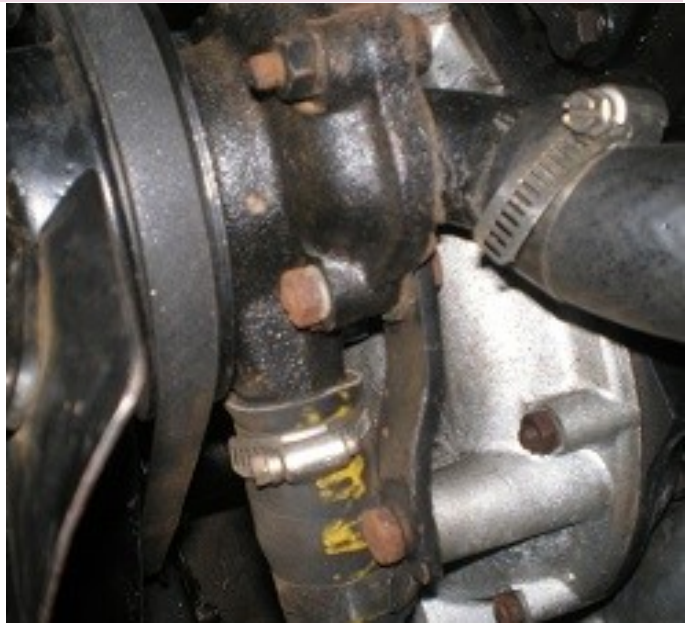
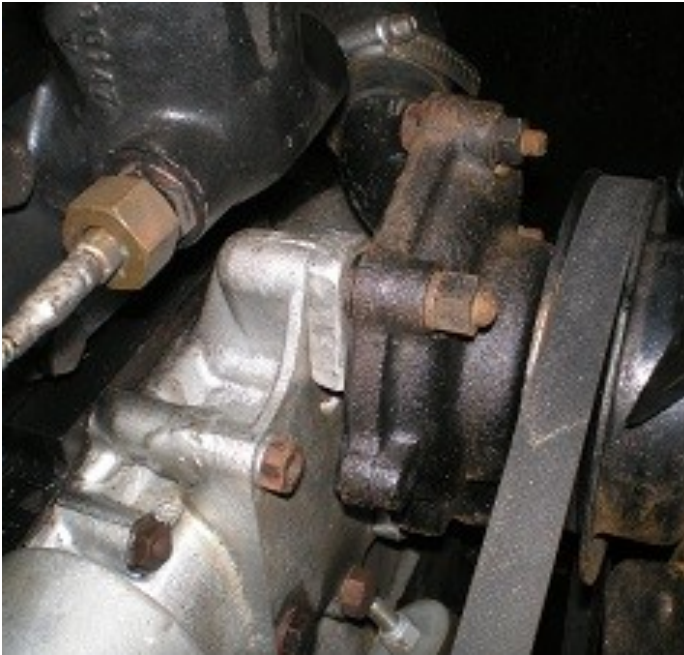
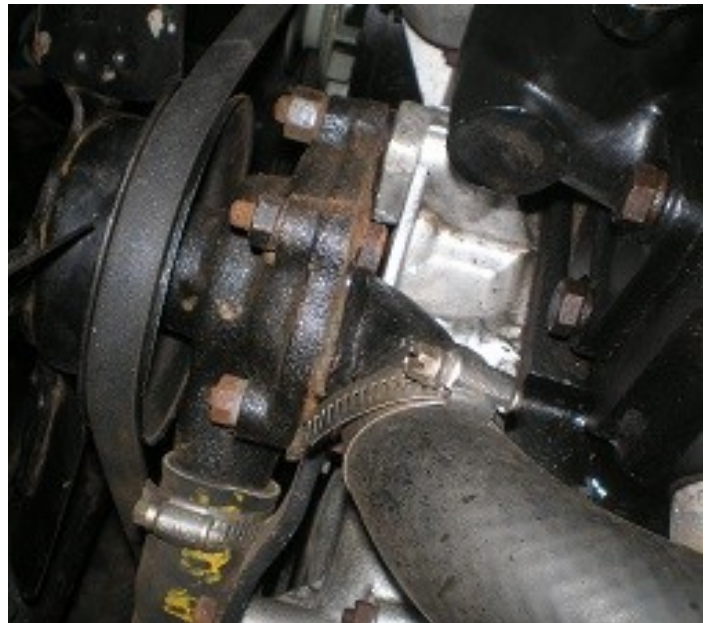
A few people are having trouble with RMF water pumps, but I may have the solution. I fitted a 1955 Holden FJ pump which is easily obtained on Ebay for \$150 Australian.

the only modification required is a 90 degree bend braised to the outlet pipe. It is of the same diameter as the water inlet. Mounting spacers required are a half inch width and these can be made from aluminium. It works very well in my RMF despite the fans distance from the radiator, in fact the water temperature rarely gets to 170 degrees even on a very hot day. Hope this may be of help to someone.
