TORQUETUBE

**Newsletter of Riley Motor Club Qld, Australia Inc.
February 2018**

RMB 50 S 7309

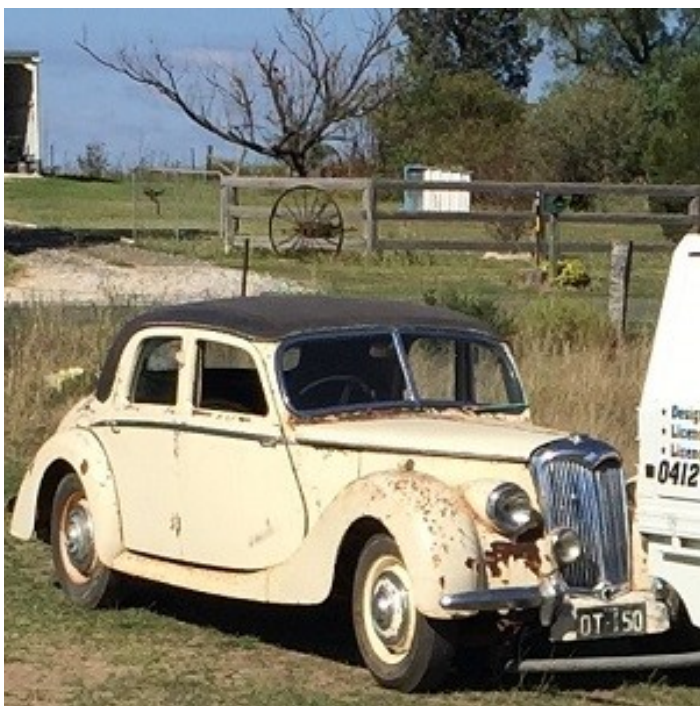
RMB 50 S 7309 was sitting in the front paddock of a homestead near Allora. The owner's wife said that she wanted him to get rid of the car, so it had been taken out of the shed with the intention of taking it to a swap meet. The car's classic shape was noticed by Aaron as he was passing by and he decided to restore it and get it back onto the road. An offer was made. The owner accepted the offer and Aaron returned with his car trailer to pick it up and take it home. Once home, the enormity of the task developed in Aaron's mind and although the intention was there to restore the car, the time wasn't. Aaron is a successful builder, works long hours, is married to Christina and they have two school age children. In the first instant a talented local panel beater was employed to sandblast the body and guards and to patch up the rust holes. Then Aaron's father, Peter whose background is in the mechanical trade was asked to rebuild the motor and gear-box. Aaron stitched the project together by giving Saturday afternoons, the only time he had available to coordinate the work and to provide assistance to the two experts who were doing the main work.

Below: car in the paddock

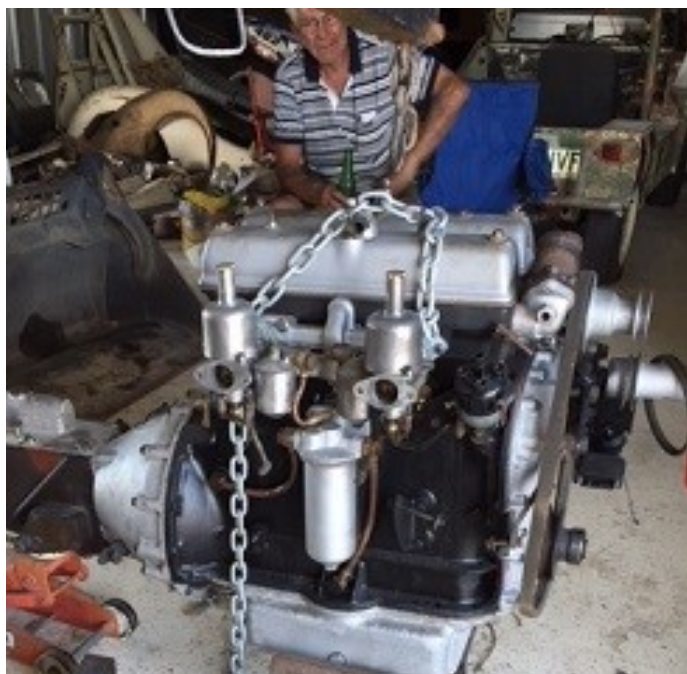
tained what was required for a rebuild. Fortunately, one of the few artisans still working in the art of white metalling was living and working in Allora and he renewed the mains and big ends. Gaskets and pistons were sourced, and the engine was rebuilt. Unfortunately, the 60 thou oversized pistons were high domed and fouled on the head so some of the material in the head was removed and the tops of the pistons machined to fit. Another issue was the timing chain tensioner. It seems to have been fitted back to front from the factory as the securing wires appeared to have the factory lead stamp on the joins.

Above: Aaron's father, Peter with the finished engine

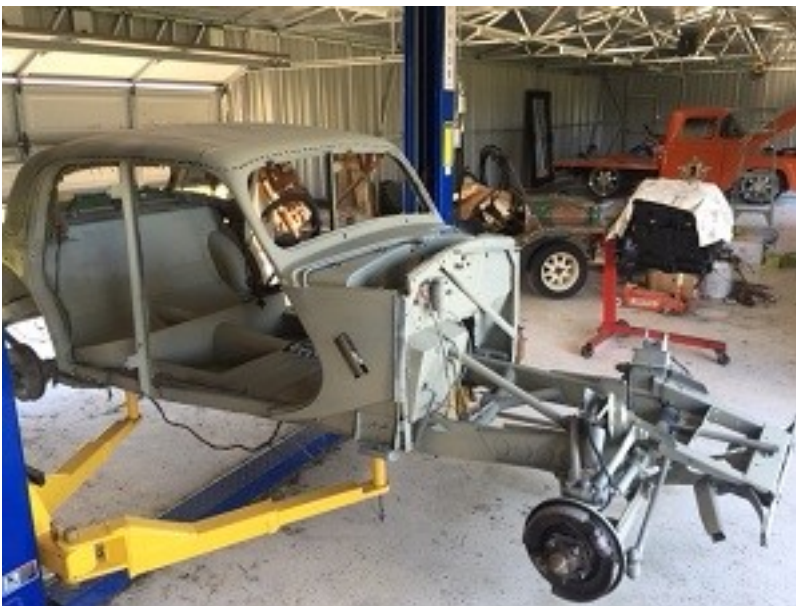
At the same time as the mechanicals were being done, the local panel beater had been spending his Saturday afternoons in Aaron's shed straightening out the body and re-manufacturing the battery box and scuttle. Fortunately, Aaron's shed (man cave) is quite large with ample room for storage and with different places for working on the car parts. At this point the tub section, the doors and most of the mudguards have been completed prior to painting.

Above: Car sandblasted and undercoated.

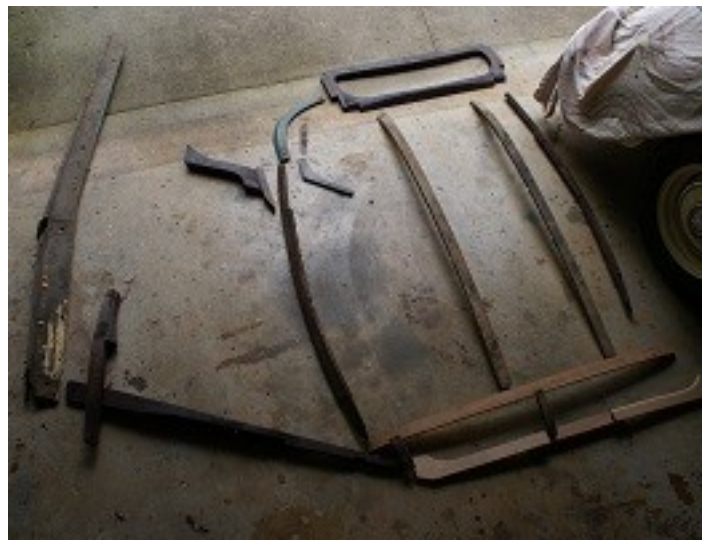
It was time now to contact Ian Henderson, the Queensland Riley Motor Club Spare Parts Officer and he was asked if the club could supply a timber frame for the car. The answer was yes, and Ian provided the 'A' pillars and the internal timber surrounds for the windows. The rest was made in my workshop and at the beginning of November 2017 a trip was made down to Warwick to deliver the timber frame, check out his car and solicit this story for Tor-

Above: timber frame pieces

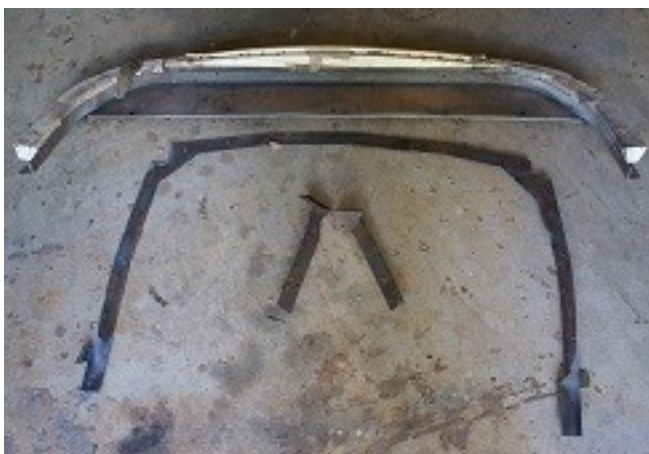
While looking over the car, some very interesting innovations were observed that had been fitted by a previous owner. A steel strap had been welded to the bottom of the 'K' panel (my name for the scuttle foundation) and the steel strap was bolted through the front scuttle timber

frame, along the top of the scuttle, covering the body number and down the other side. This was to stiffen the front end. Readers may remember a comment made in the December issue of Torquetube about testing the A frame for integrity. The comment was that rot in the centre of the pillar could be identified by looseness of the striker plates and the bonnet catch knobs. In this case the A pillar was rotten, and the middle of the posts were missing altogether. To resolve this issue, steel straps were bolted to the underside of the out-side bonnet rests to plates that had been positioned behind the door

Above: The top piece is an angle iron that wrapped around the rear with the parcel shelf on the bottom and the rear window frame bolted to the top. The bottom strap is flat steel cut to the shape of the scuttle timbers. And in the middle are the striker plate bases.

The steel strap around the scuttle was cut away from the 'K' panel and the half dozen bolts removed that had been bolted through the timber surround in front of the battery box and tool shelf and it was taken off. At this stage it was safe to do that as the scuttle had been stiffened by the introduction of new cilles that had been bolted to the K panels. Taking the steel off the front of the scuttle revealed the body number and when the new timber was introduced the number was replicated on the timber. After the bottom window rail and quarter panel timbers were fitted to the scuttle the 'A' pillars were set in place and several hours of nipping and tucking were conducted on the 'A' pillars to get the window surround into precisely the same place where it had begun life

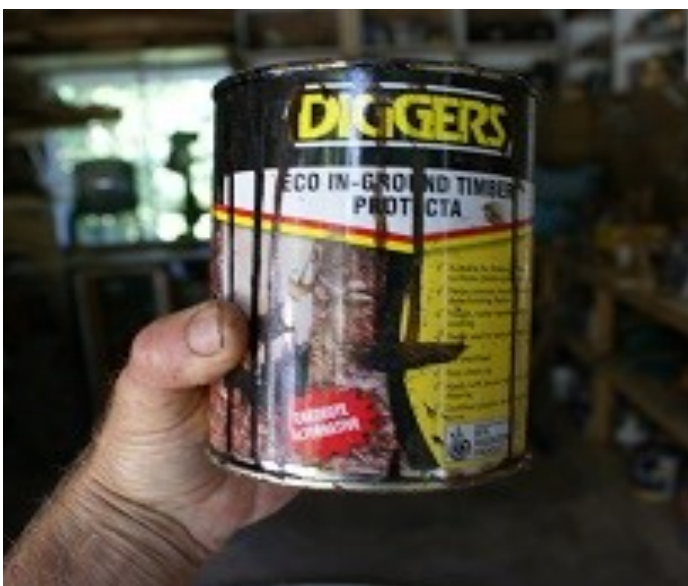
Once the 'new' timber had been brought home, some of it was reduced to the shapes required for cilles, corner blocks and rear window corner frames and these were painted with a non-creosote paint. This paint is used commercially to protect timber that is used inground such as fence posts. The paint takes a week or two to dry so this is what happens.

Below: The paint used on the timber frame

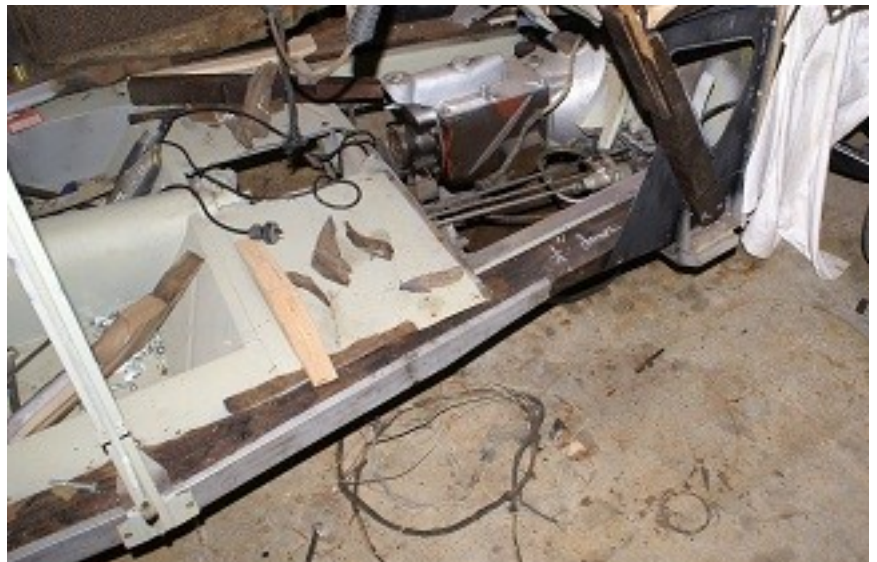
As you would expect the first thing done was to put the foundations of the body into order so the cilles that had been manufactured from spotted gum, painted with a water proofing, and skinned with steel were brought down from the timber shelf. Interestingly the timber was originally cut for 1-inch floor boards and 6 mils needed to be removed for the Riley application. Not all was lost, however, as the saw dust went straight into the compost bin for our gardens.

Below: One of the cilles fitted to Aaron's car

life of half a million years and second hand it saves it from land fill. Finally, the cill was set up so that it was repositioned (almost) exactly where it had been when originally set up. This required a little bit of imagination as the original cilles had compressed and sagged outwards. The replacement procedure was repeated on the passenger side and the cilles were bolted into place into the 'K' panel, 'B' pillar and tub.

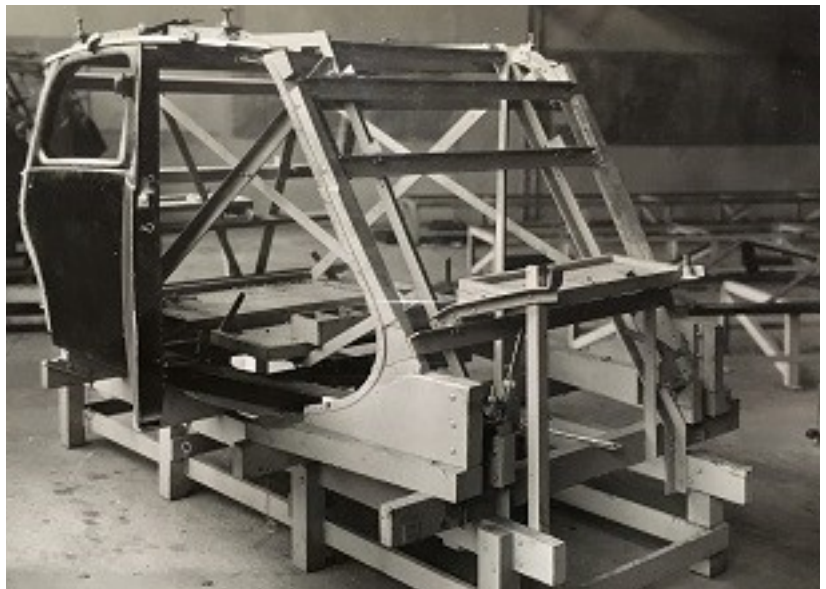
Above: A timber jig used to make Riley doors

They had all been made on jigs in the factory but how many jigs were there? Then another discovery was revealed. The jigs were timber built and wore out, but how long did they last before being replaced? The result is that each Riley is likely to be uniquely shaped and if one of your doors is damaged you may not find another door that will make a precise fit. The result was that Aaron's doors were brought to site with the intention of fitting the body up to them.

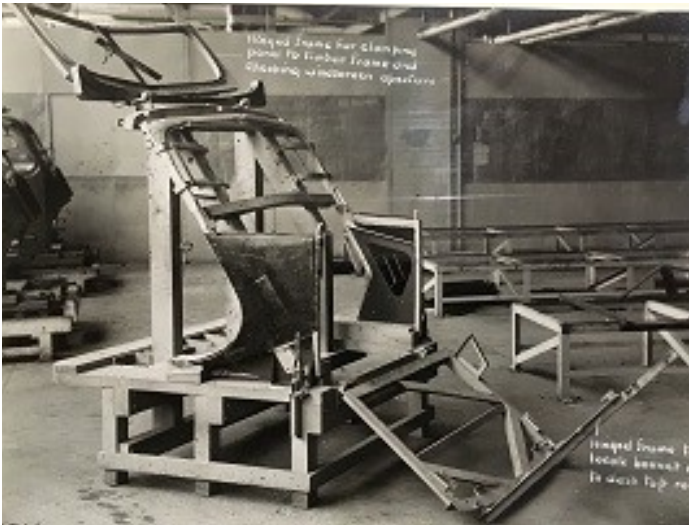
Below: Riley works front end jig

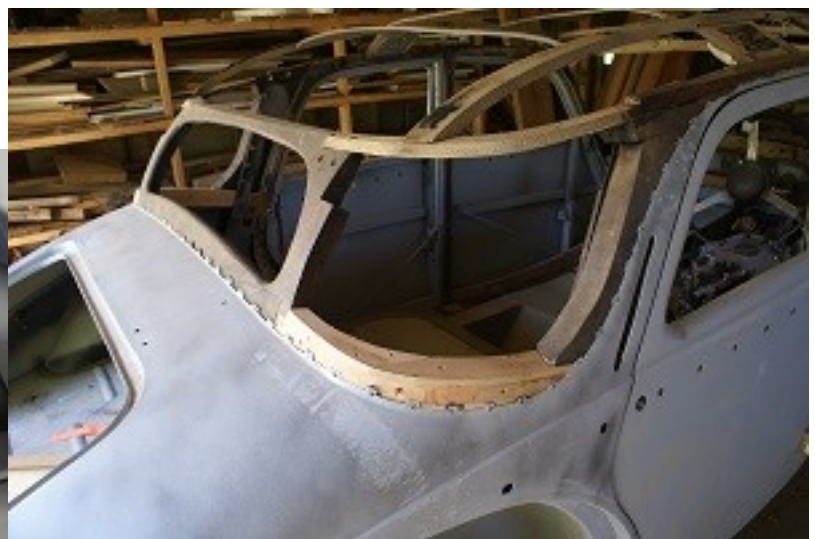
After the shock absorber bases were fitted, the steel that had been introduced to go around the rear window was removed with the rear window frame and the bottom corner blocks. The rear window base had rotted out but also much chipboard sandwiching had been introduced in place of the shelf fillet and a piece of Masonite had been used to replace the parcel shelf. The nail sick trafficator blocks were replaced as the first step in framing the rear of the car. The tops were pressed up against the remains of the cant rails and screwed into place. The new rear window frame was made with Parmetia, a light hard wood as were the bottom corner blocks. The rear window was then fitted and screwed to the tub. The rear window corner blocks that had previously been made from three layers of Parmetia, glued together were trial fitted and then removed to adjust their shape and refitted again and screwed into position. The roof rails and the ply rear window corners were then screwed into the new rear window frame.

Above: Rear corner blocks fitted

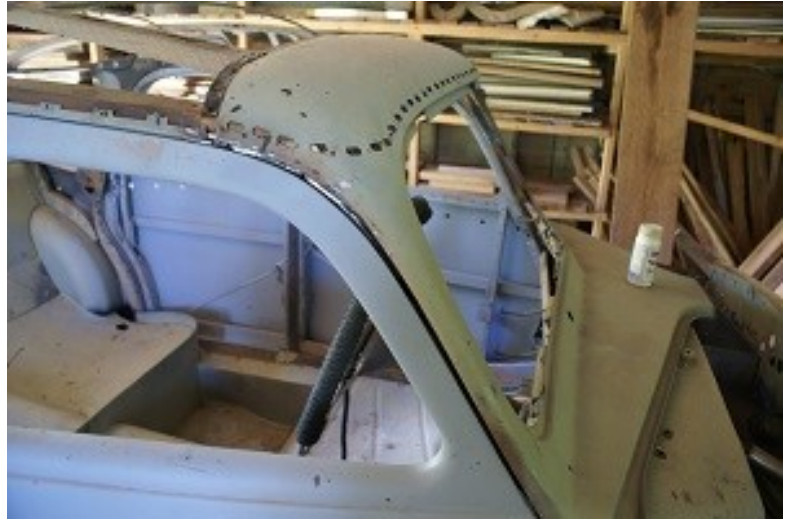
tion of both front and rear doors. An easy guide is to set the cill into position so that the front hole at the base of the B pillar is fitted onto the flat surface of the cill that runs towards the A pillar. That provides the correct angle for the doors to open and close without the hinges binding when attempting to close the front door.

Above: front door fit

After that the doors were fitted, and it was found that the rear end of the tub needed to be set at $3/8^{\text{th}}$ of an inch, the front of the tub at $3/4^{\text{th}}$ of an inch and the 'B' post and the scuttle needed to be set at $3/8^{\text{th}}$ of an inch. After these adjustments were affected the doors made a near fit and over the next few hours the body and door positions were tweaked to achieve even gaps around the doors. Of note is the angle of the 'B' pillar; a $1/16^{\text{th}}$ of an inch makes a big difference to the opening and closing posi-

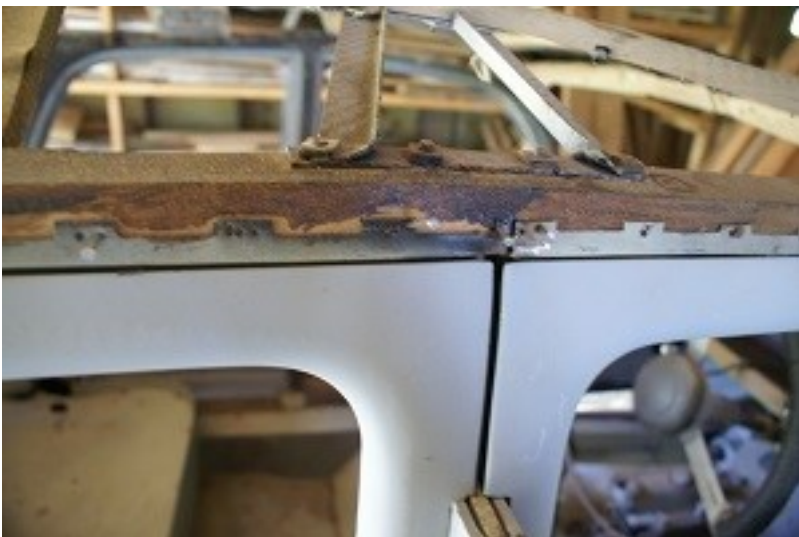
The old driver's side cant rail was then removed but the metal bracket that locates the top of the 'B' pillar was left in place. The first thing done to replace the cant rail was to fit the new rail up to the metal frame to mark the locations of the domed bolts. The 'B' pillar needs to be completely removed from the car to fit it to the cant rail as the domed bolt heads are set into small strips of timber that form the filling for the door jam and are screwed over the top of the domed bolts into the cant rails. After fitting the cant rails to the 'B' pillars these were fitted into the rear window door jam. Slight adjustments were then made to the cant rail to make a good fit and then the bolts passed through the metal bracket and the nuts done up. A few flat head nails were then used to temporarily pin the rear door jam into position onto the cant rail. This procedure was then repeated on the passenger side of the car.

Above: Cant rails fitted

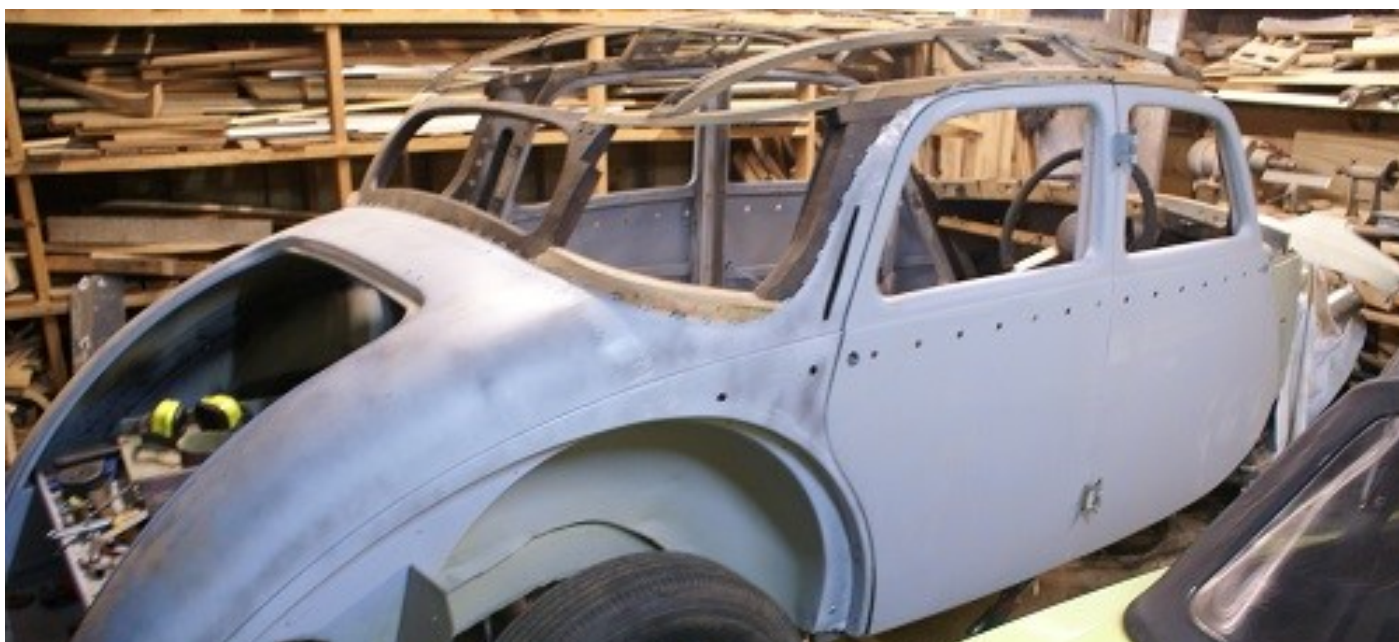
Below: Rear door fit

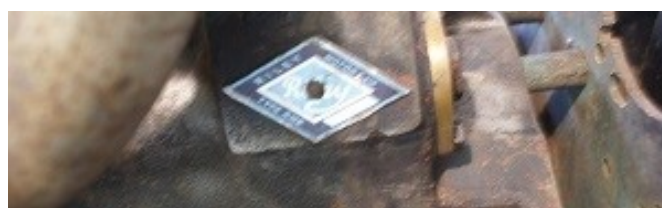
Harold, the 1948 RMB has an aluminium diamond on the passenger side of the block behind the exhaust manifold. It has the number, '6992' stamped on it in very small numbers. When registering Harold for the first time early in 1987 the WA Department of Transport officer insisted on me stamping the engine number on the block. It was disappointing but nec-

essary. I am told that the engine is likely to be a replacement of the original engine as the aluminium diamond was introduced later by Nuffield.

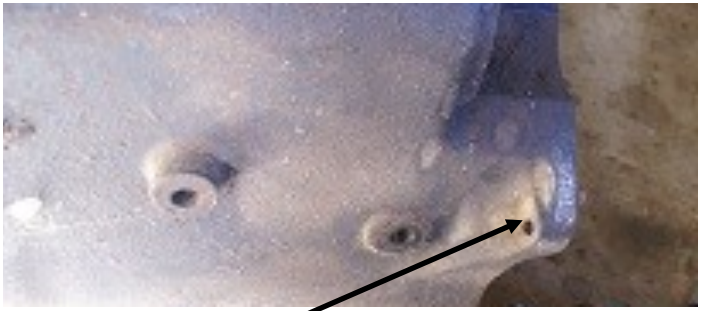
George was acquired from Mike Olive on the Sunshine coast. I understand that he has been in the hands of Queensland club members for many years and his engine number is stamped on the leading edge of the block just above the distributor. It is numbered, '5421'. Numbers stamped near the distributor start with a 'B'. This number was also stamped on the timing cover but over sixty years with maybe more than one re-build many cars have engines that have different numbers from the one on the timing cover. In Ian Henderson's Drophead the engine number is B 2787 and the timing cover is B 3651.

Above: Engine number on the leading edge of the block adjacent to the outlet cam

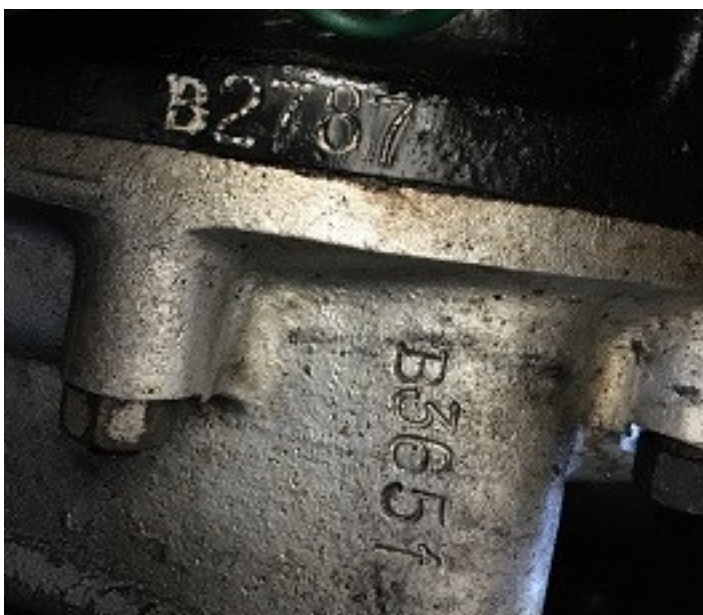
Above: Ian's Roadster engine number

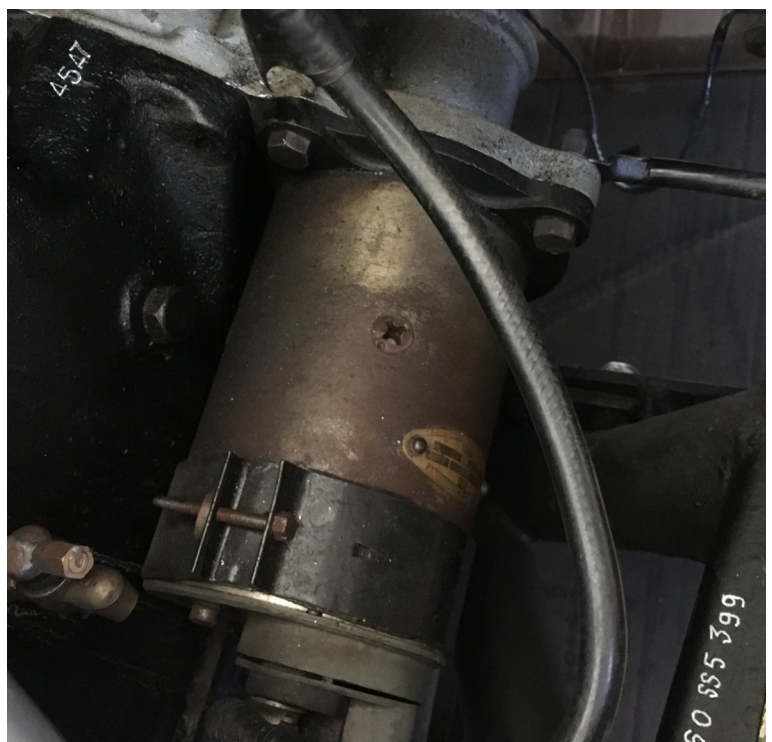
Below: The chassis number and engine number on Ian's Roadster

If your car has been cared for by previous owners, the chassis number is stamped on a brass plate affixed to the front of the scuttle. In Albert's case the plate was posted to me by Ross McOmish who was the previous owner. How he still had it I do not know. At the time of his arrival, there was very little timber left on Albert anywhere. Thankfully, the number on the chassis was not corroded away and it was found on the chassis adjacent to the starter motor. Interestingly a few Riley Club members have asked me, 'but does it have a 'D' stamped in the number?' 'Yes, it does was the answer. The number is 60 D 6579

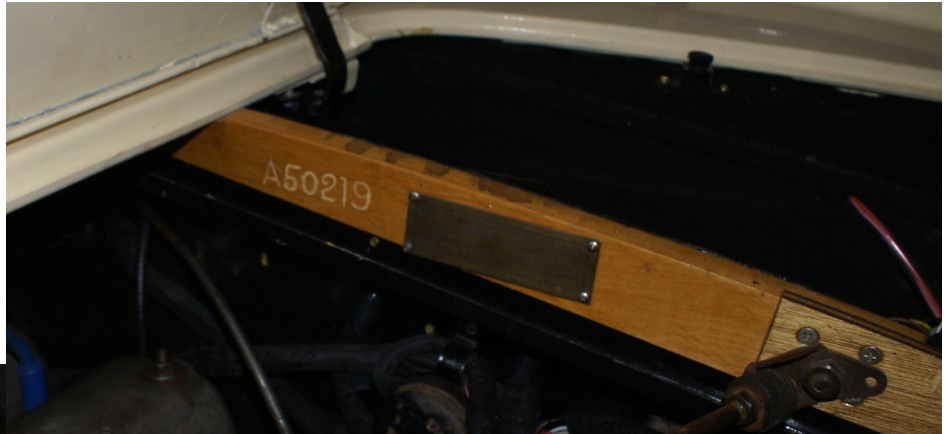
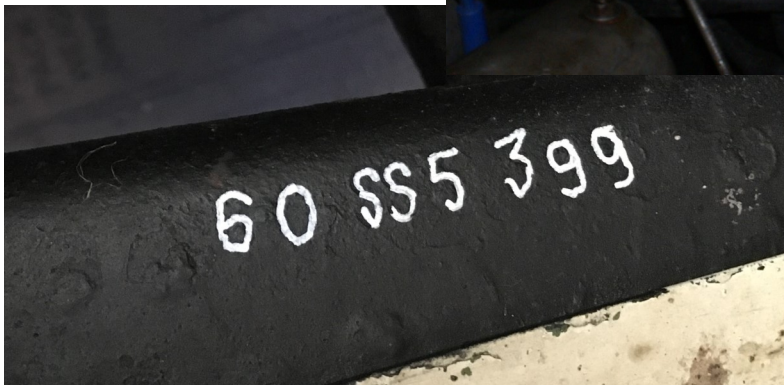
Above: Chassis number on Ian's Roadster

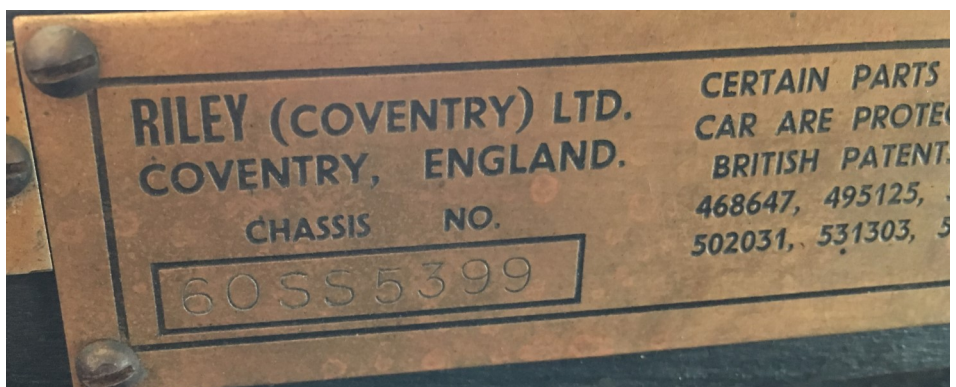
Below: Chassis plate number on the bulkhead timber of Ian's Drophead
